DEPARTMENT OF OCEAN ENGINEERING

MASSACHUSETTS INSTITUTE OF TECHNOLOGY CAMBRIDGE, MASSACHUSETTS 02139

MATERIAL DEGRADATION IN HEAVY STEEL PLATES CAUSED BY BENDING WITH A LASER

Course 13A June, 1984

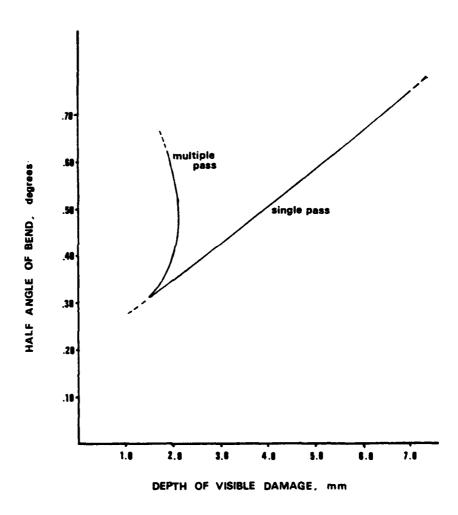
FIGURE 21

Figure 21 is a plot of the depth of the visible damage versus the half-angle of the bend. Figure 22 is a plot of the depth of visible damage versus the heat input. There is a clear correlation between the method of bending and the depth of damage. For the same degree of bend, a multiple pass method does much less damage to the plate than a single pass method.

Although a single-pass procedure is more energy efficient, it produces considerably more material damage than a multiple-pass procedure. Therefore, the latter is recommended.
